Rooftop Solar PV - System Repair and Optimisation

Location: Kent Client: Private

Size: 110 kW(p) + 70 kW(p) extension

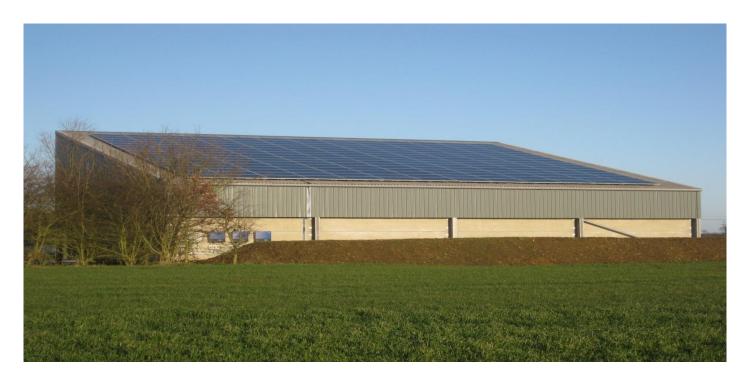
The Energy team have assisted a private client to troubleshoot a 110 kW rooftop solar PV that had historical problems of low energy yield and system outages. Our analysis indicated that the system was underperforming by 25% for its location and orientation.

Our engineers performed a technical appraisal of the system and test results identified several electrical issues including a faulty inverter, incomplete DC connections of the panels, constant tripping of the G59 isolation relay and current leakage through the neutral that caused a diesel generator to malfunction. All this problems directly affected the uptime of the system, causing low yield and loss of income.

Our engineers instructed a solar contractor and coordinated the repairs and replacement of the inverter at no cost to the client. A post works analysis revealed the system is now consistently +15% excess generation which is a total of a 35% improvement from its previous condition. Based on this improvement the client invested in a further 70kW system.
