## Rooftop Solar PV Fault Finding and Remedial Works

Location: Hertfordshire

Client: Private Size: 50 kW(p)

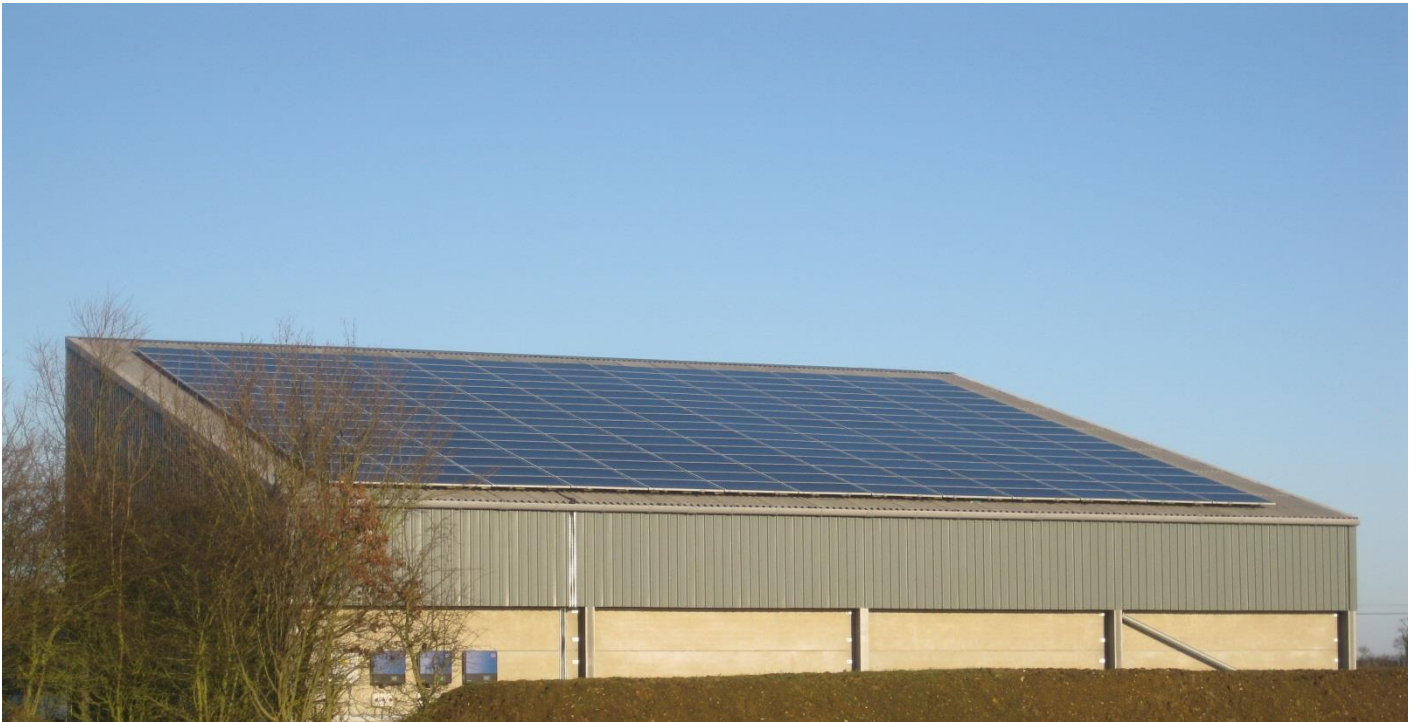
The Energy team have assisted a private client to troubleshoot a 50 kW rooftop solar PV that reported continuous tripping of inverters during sunny intervals. The problem had been previously investigated by the installer and the electricity supply company but without success.

One of our engineers carried out a number of electrical tests in order to determine the cause of the fault. Error analysis of the inverter logs indicated that the equipment was shutting down due to high voltages from the incoming supply.

Our engineer liaised with the District Network Operator (DNO) to carry out local tests on the grid. These confirmed that although there had been brief periods of high voltage in the area, they had been operating within supply agreement tolerances. Our engineer then contacted the inverter manufacturer who confirmed that although those voltage spikes were within the agreed operating tolerances for the DNO they were outside the voltage levels defined in the inverter firmware, resulting in a shutdown of the equipment. Although simple, this problem was particularly difficult to troubleshoot as its occurrence was seemingly random.

Once the fault was identified, our engineer coordinated firmware updates for all inverters on site with a local contractor. This inexpensive corrective action dramatically decreased the downtime of the installation and had an immediate effect on generation yields and income.
